Structural Integrity Reserve Study (SIRS) Report

Client Name: Bonavida Condominium Association Inc

Address: 20100 W Country Club Dr,
Aventura, FL, 33180

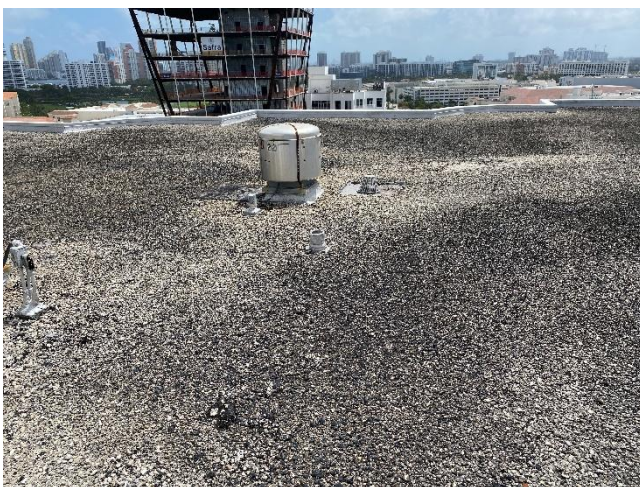
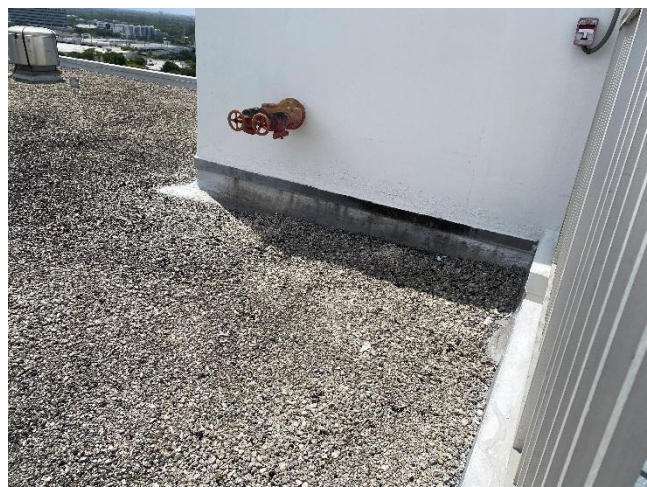
Condition Analysis: Poor

The existing system was compromised of a built up system. Although the system is considered a low slope system, it should still properly allow the drainage of rain water within 24-48 hours. The current system exhibited concentrated areas of weathering and deterioration which over time can result in the reduction of the remaining useful life (RUL). As routine maintenance, manufactures recommend biannual inspections and additional inspections after major storms.

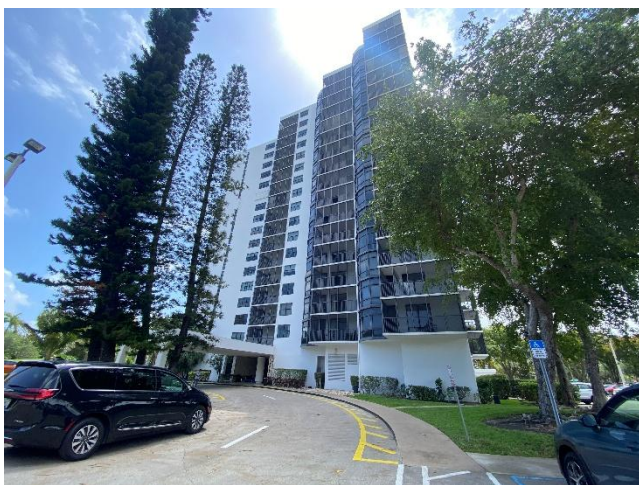
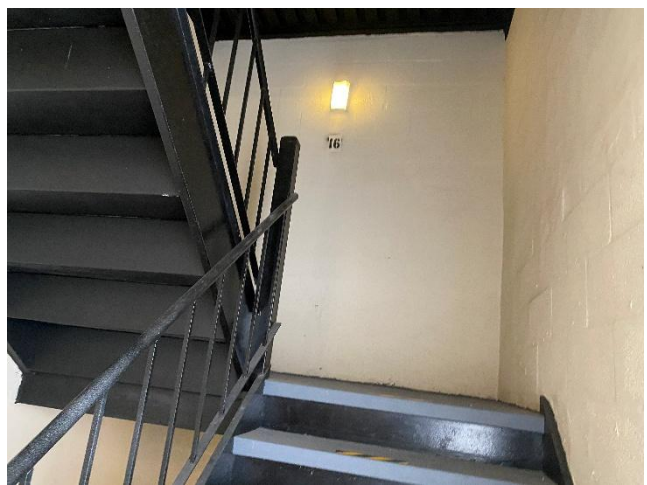
Condition Analysis: Poor

The existing structures were built from a combination of reinforced concrete members and masonry walls. Buildings of this age will typically undergo a concrete restoration project to tend to any deterioration of concrete inclusive of cracks, spalls, and moisture infiltration. During the inspection process the building was acoustically sounded to evaluate the extent of deterioration. Overall, the condition of the concrete was poor with many areas experiencing cracks or delamination of concrete.

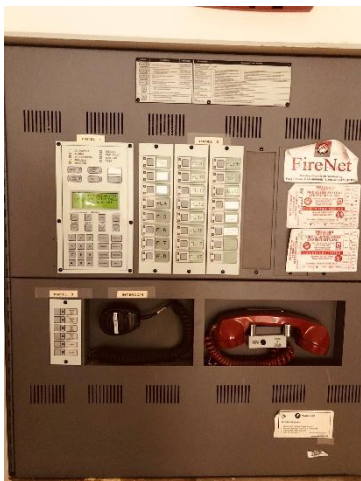
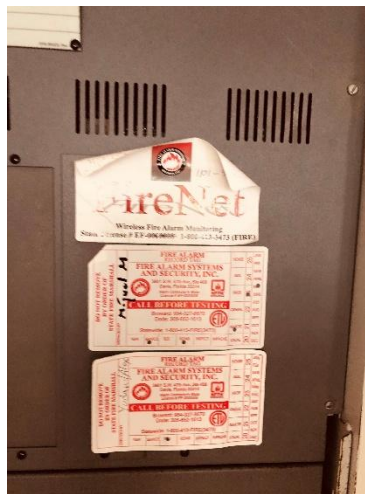
Condition Analysis: Fair

Fire alarm equipment is assumed to have been designed and installed properly and is assumed to comply with all relevant building codes. Regular testing and inspections should be conducted. Cost estimates are based on quantity and type of existing equipment, not including any expansion or upgrades, which may be required and assume that existing wiring can be re-used with only panel and devices replaced.

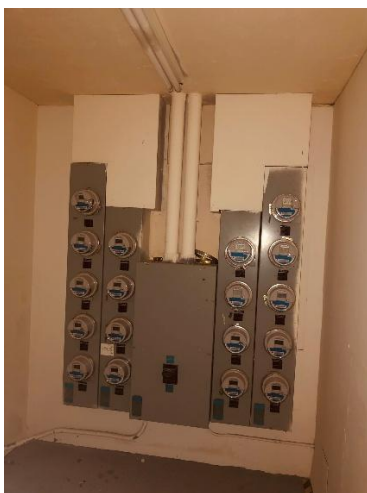
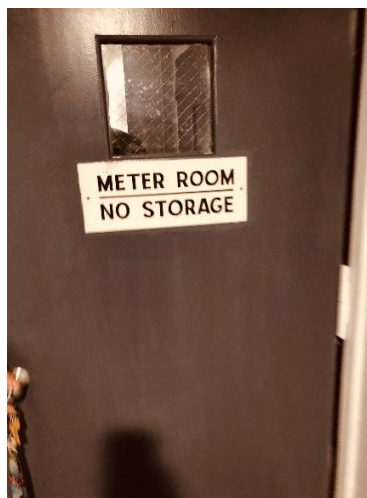
Condition Analysis: Fair

No major concerns or project history reported by the client during the current engagement. In accordance with Florida Statutes, a Structural Integrity Reserve Study is based only on a visual inspection. Further analysis of electrical components requires testing beyond visual inspection diagnose and detect problems which may require immediate repair or replacement. It is recommended that the client hire a qualified electrical contractor to accurately determine replacement timelines and costs.

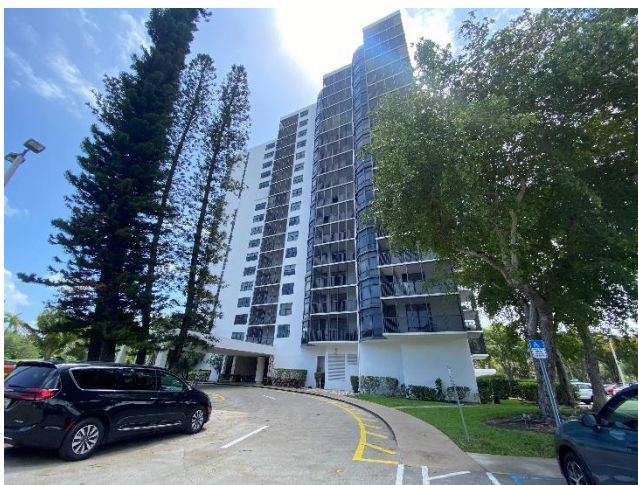
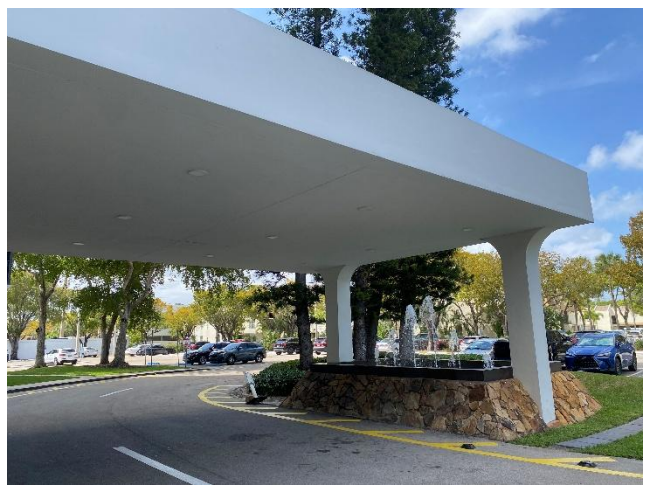
Condition Analysis: Fair

The current paint and waterproofing systems of the buildings were in fair condition, however are at the end of their EUL. While the overall performance remains adequate in terms of protecting the structure from the elements, there are areas where waterproofing has been compromised and can result in concrete deterioration.

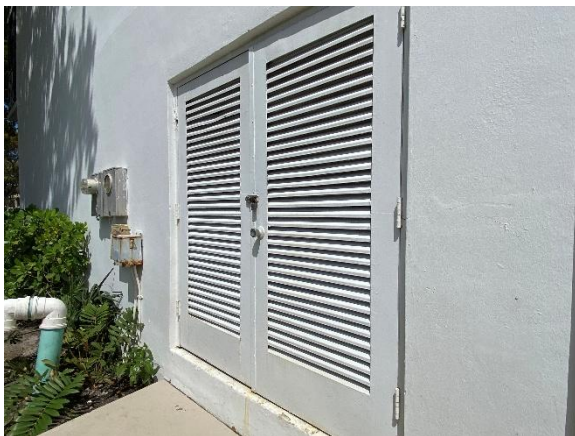
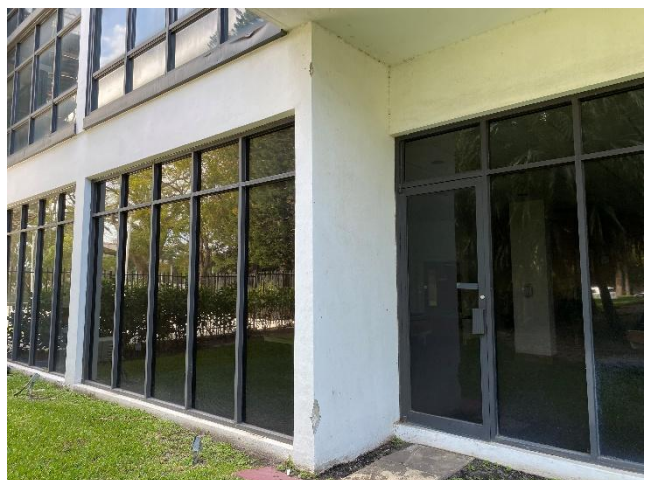
Condition Analysis: Fair

The windows and utility doors should be inspected periodically and repair as needed. Windows should be resealed as part of an active maintenance cycle while utility doors should be painted along with building exteriors to preserve appearance and extended useful life.

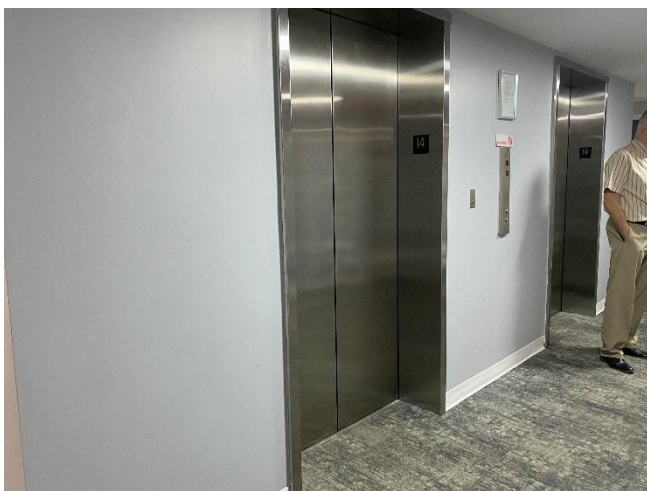
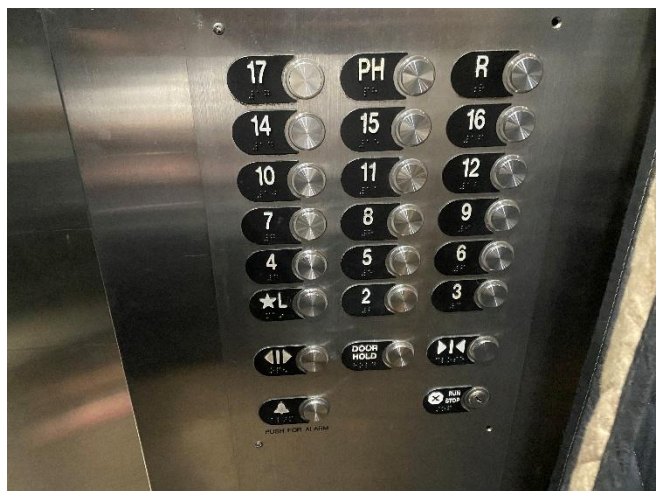
Condition Analysis: Fair

Elevator modernization was completed on the all building in 2004, however the full extent of the modernization was limited based on information received. A modernization project typically includes replacement/upgrade of controller, mechanical door equipment, push-button fixtures, and minor electrical work or fire alarm work. Elevators should be periodically inspected and tested. Hydraulic systems may need replacement based on age, functionality, and frequency of use.
